EM 1110-2-2002

30 June 1995

Engineering and Design
EVALUATION AND REPAIR OF CONCRETE STRUCTURES

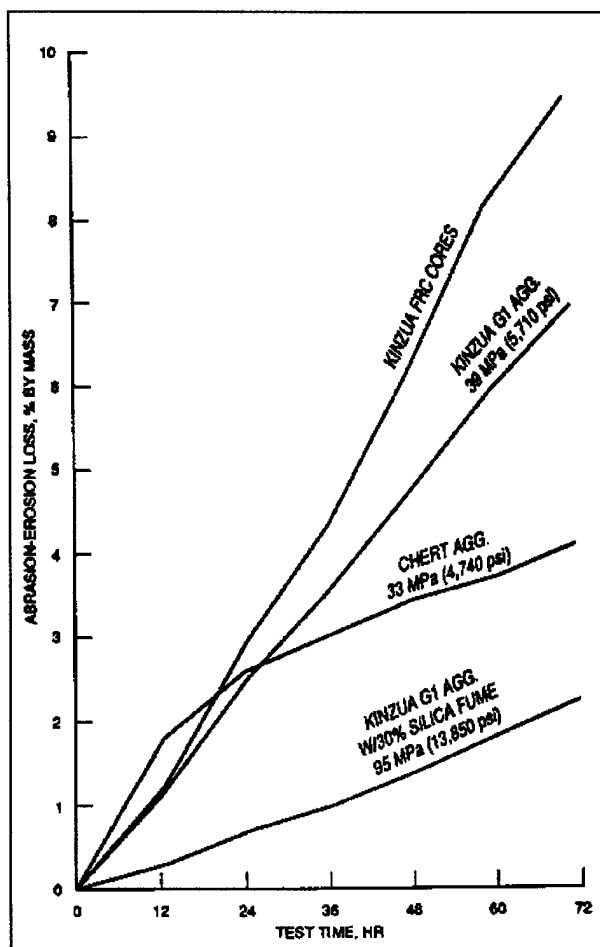
Figure 8-35. Results of selected abrasion-erosion tests, Kinzua Dam

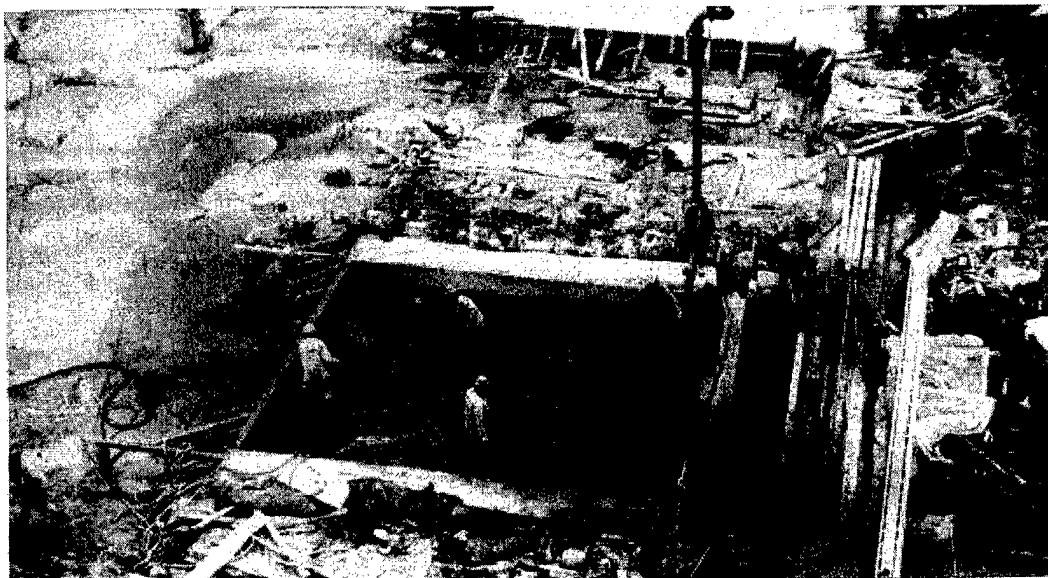
Figure 8-36. Pumping silica-fume concrete into the stilling basin from the top of the right training wall, Kinzua Dam

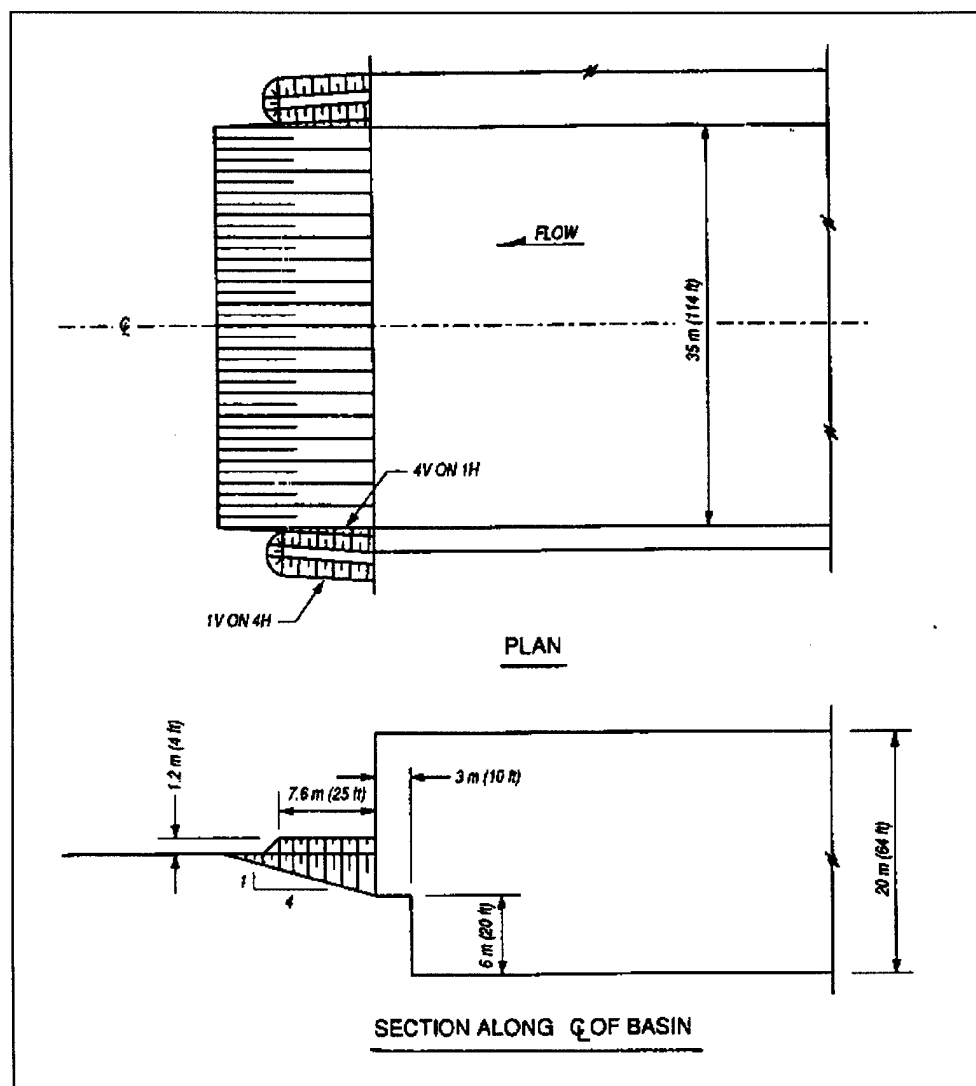
Figure 8-37. Stilling basin wall extension fills, Dworshak Dam

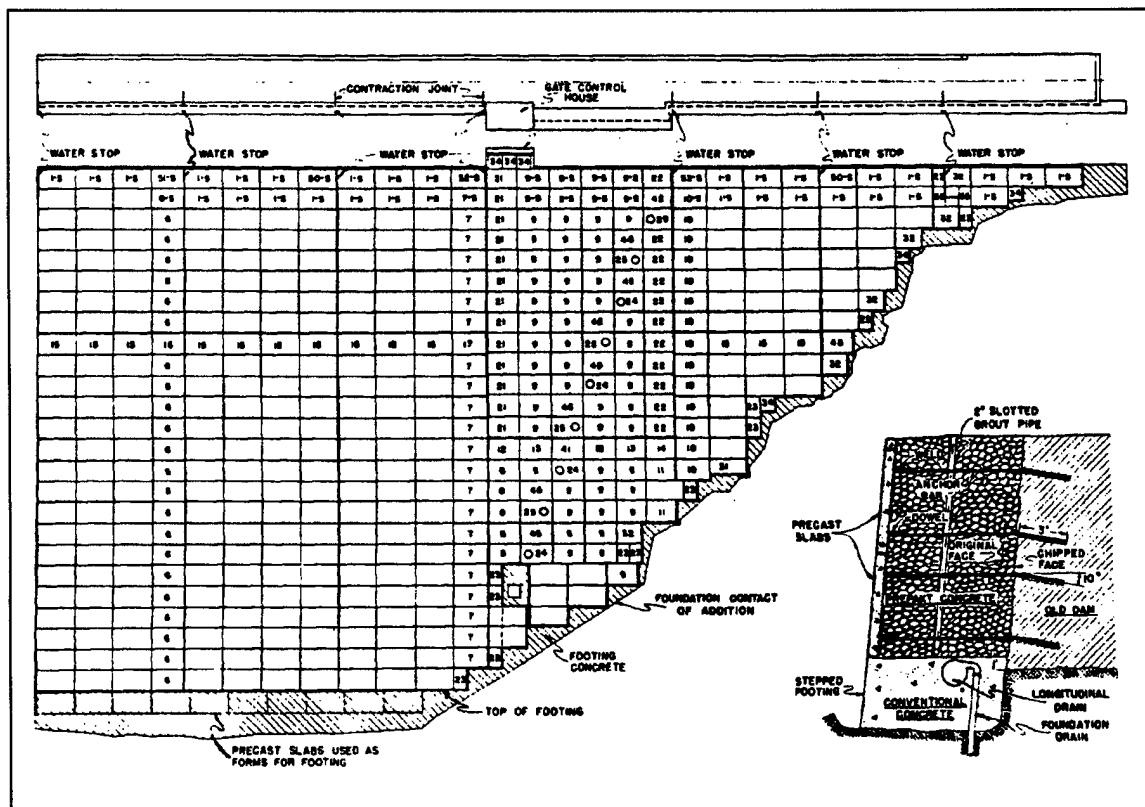
Figure 8-38. Footing and slab layout, south half of Barker Dam (from Davis, Jansen, and Neelands 1948)

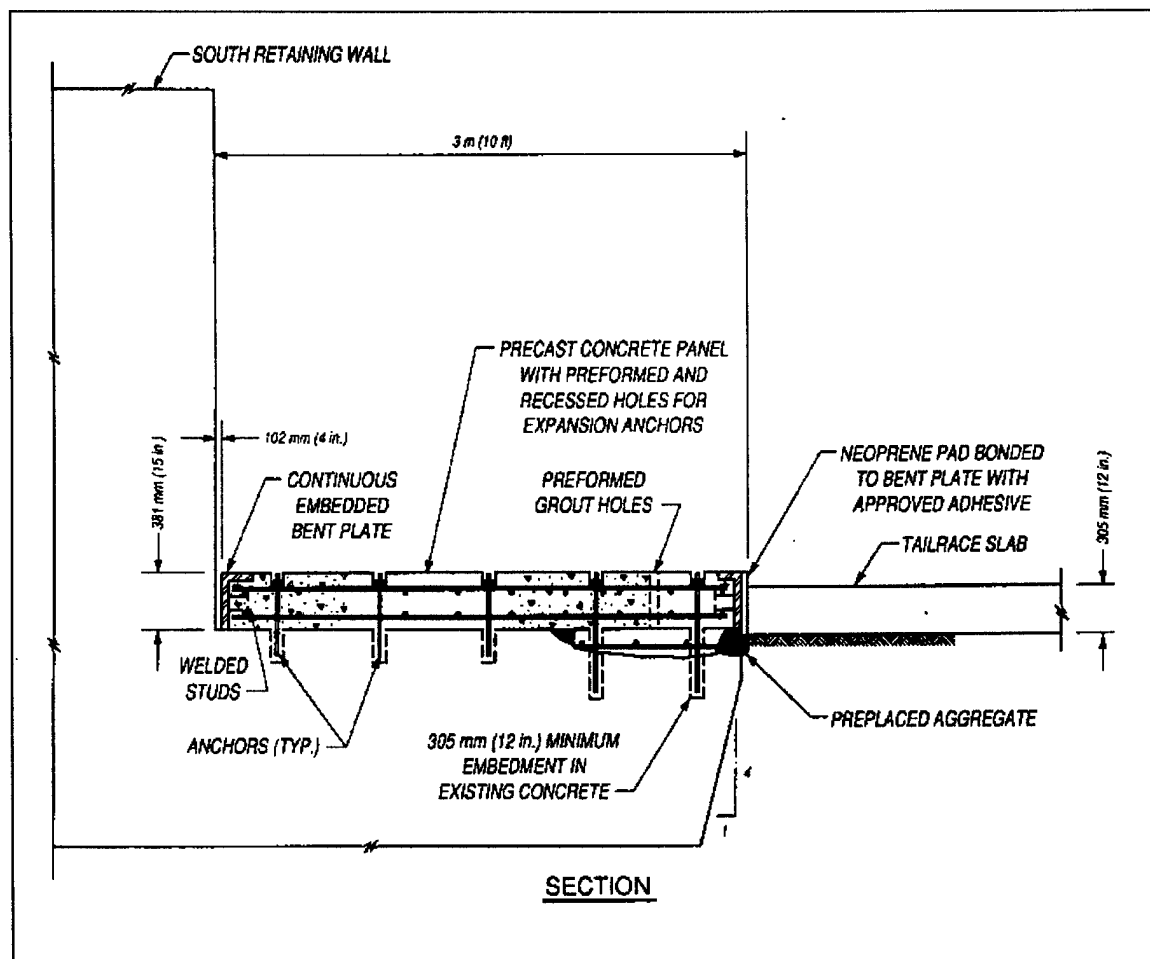
Figure 8-39. Underwater repair of concrete spalling, Gavins Point Dam

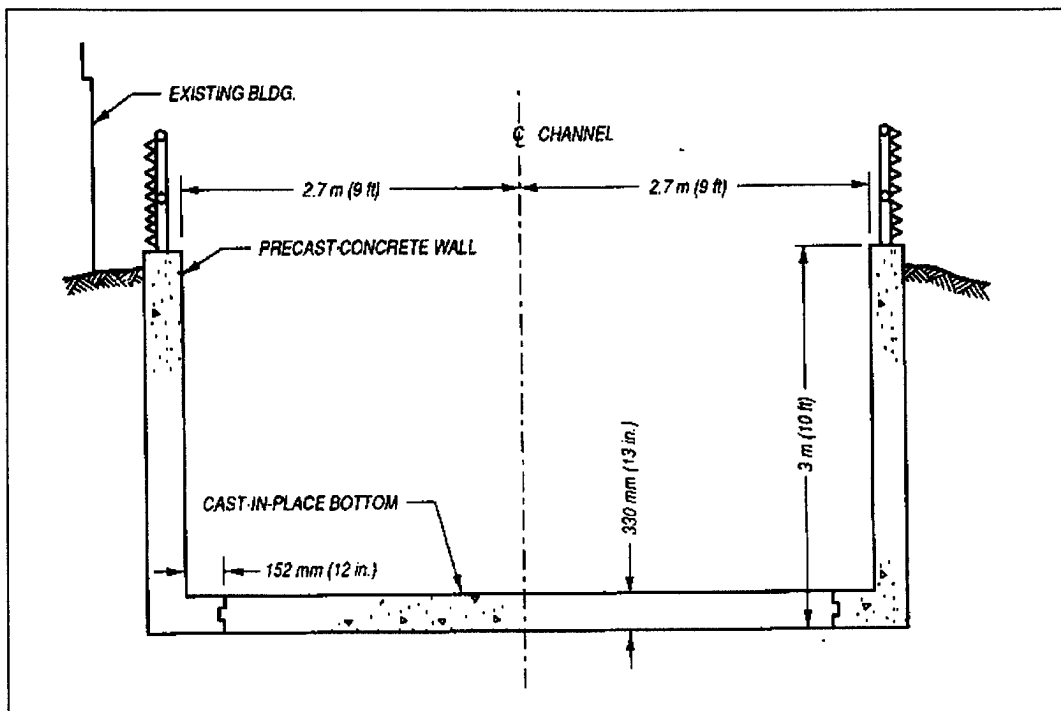
Figure 8-45. Typical channel repair section, Placer Creek (after Hacker 1986)

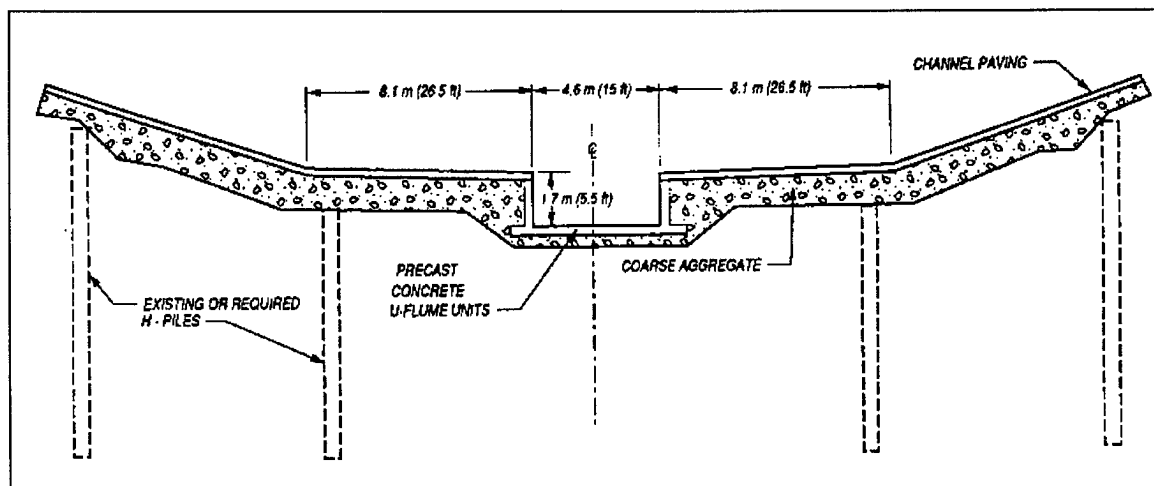
Figure 8-46. Cross section of precast low-flow channel, Blue River Channel (after Mitscher 1992)

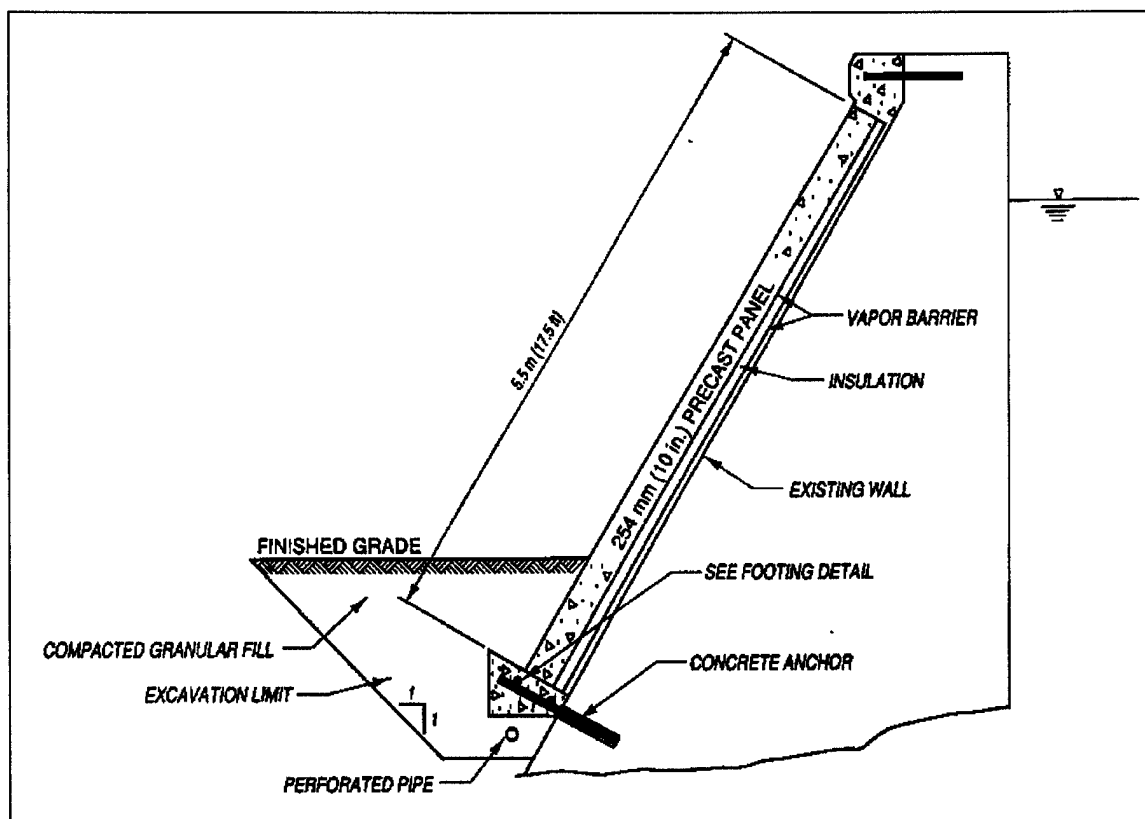
Figure 8-49. Typical repair section, Joliet Channel Wall

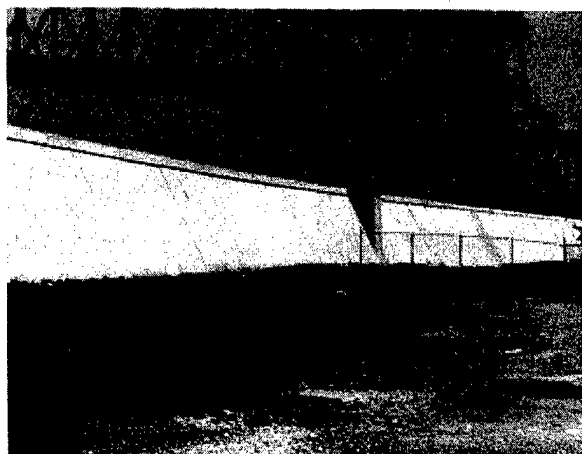
Figure 8-50. Joliet Channel Wall before and after repair

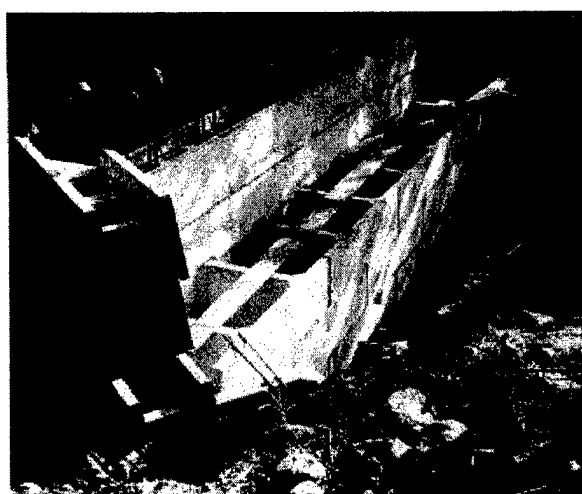
Figure 8-51. Top view of precast abutment prior to backfilling, Ulsterville Bridge

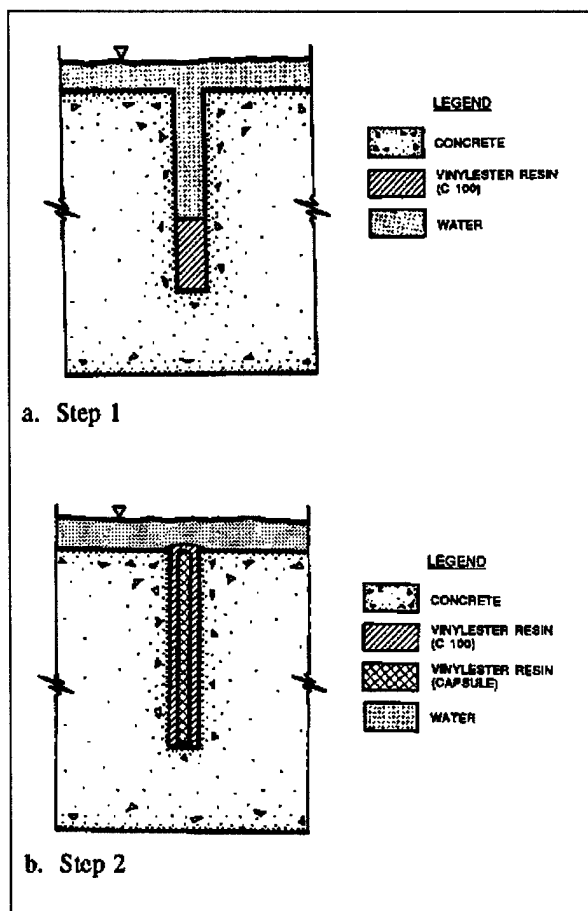
Figure 8-56. Two-step procedure for anchor installation under submerged conditions

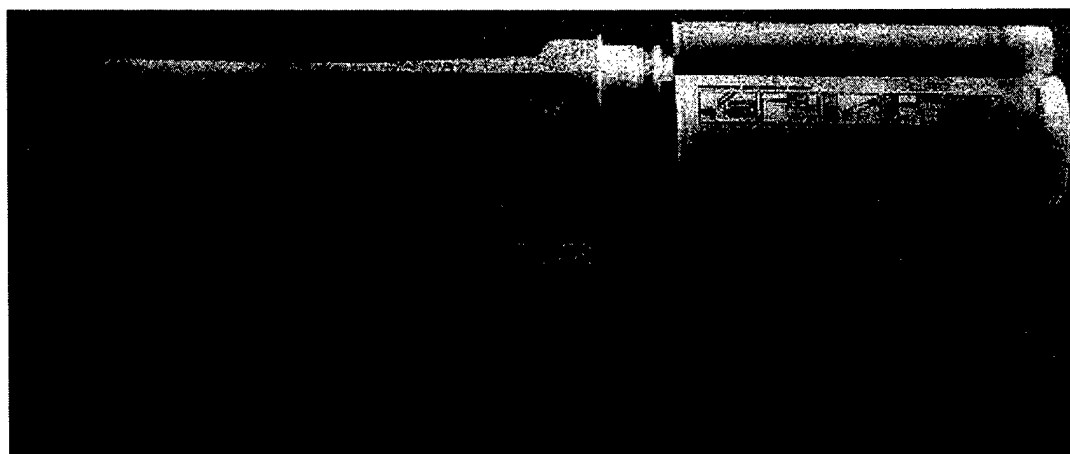
Figure 8-57. Paired disposable cartridges and static mixing tube

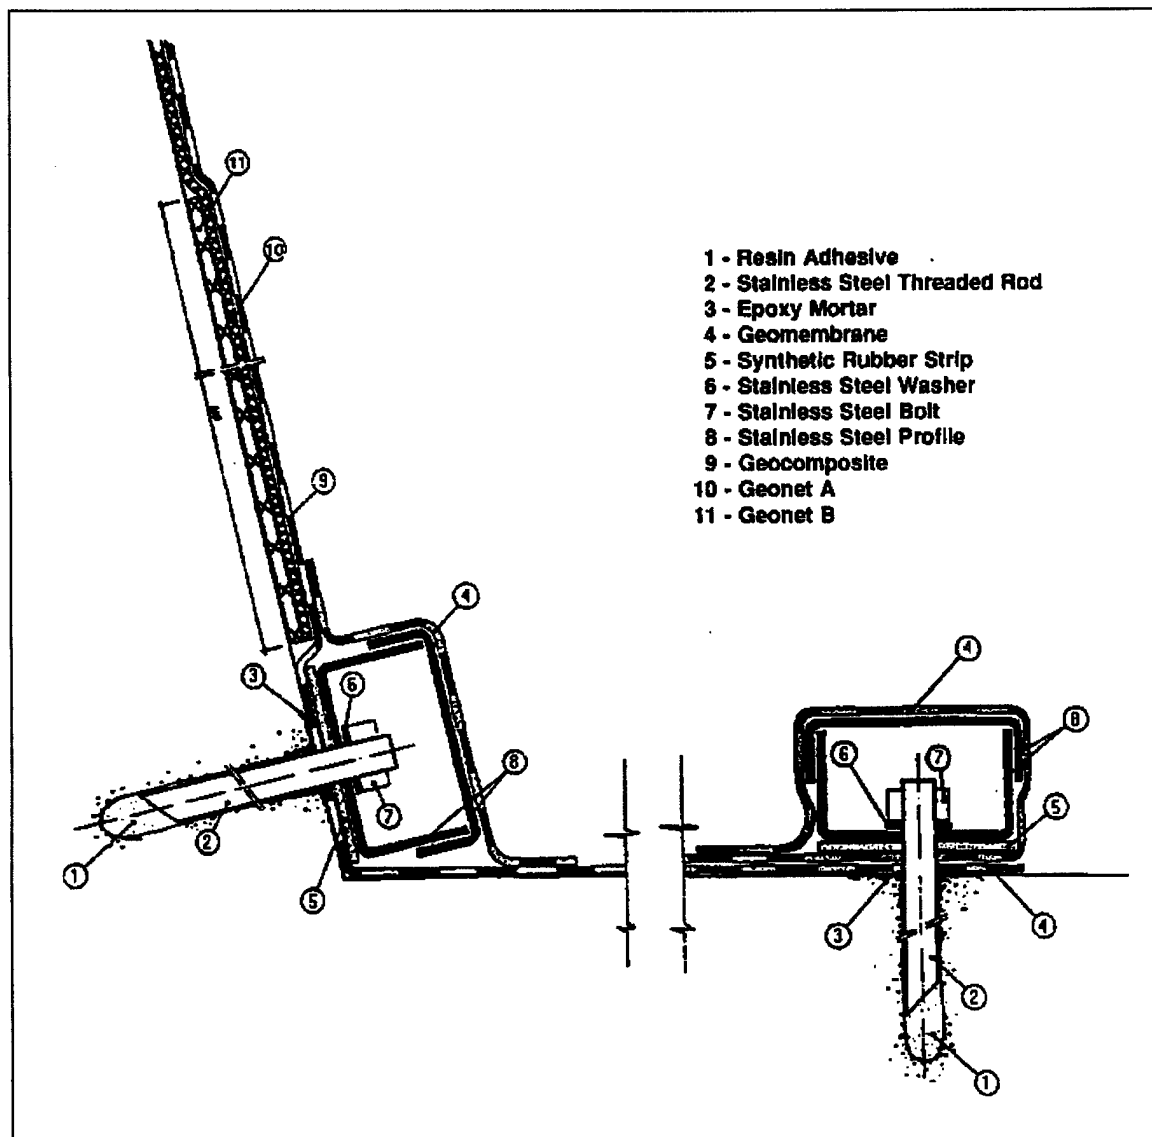
Figure 8-59. Detail of sealing profiles

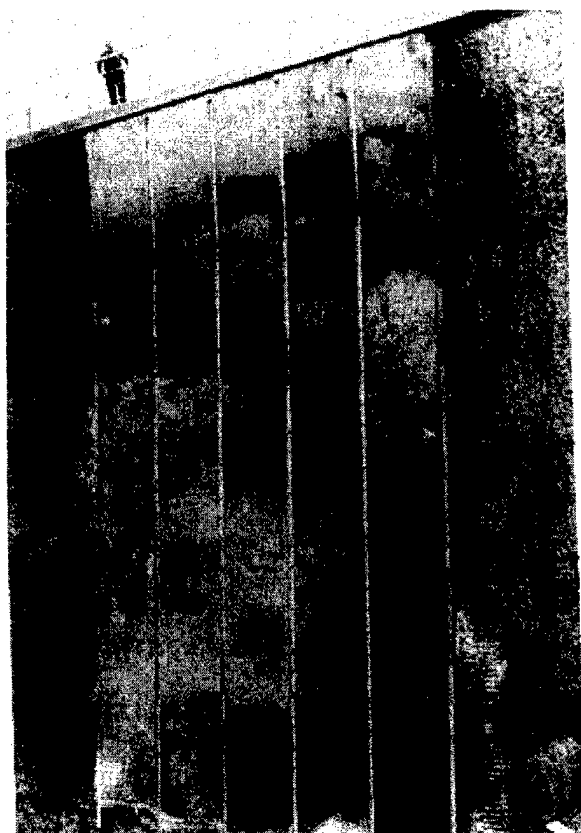
Figure 8-61. Steel profiles embedded in shotcrete, Cignana Dam

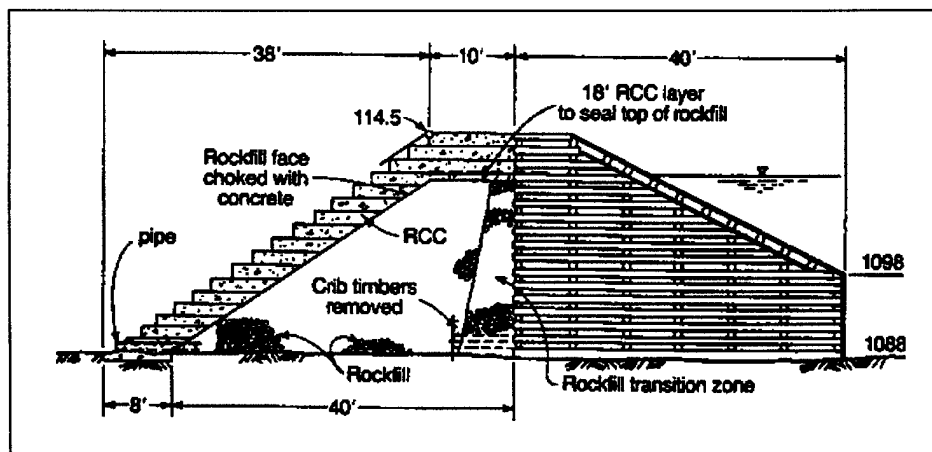
Figure 8-63. Section through modified dam, Ocoee Dam No. 2 (Hansen 1989)

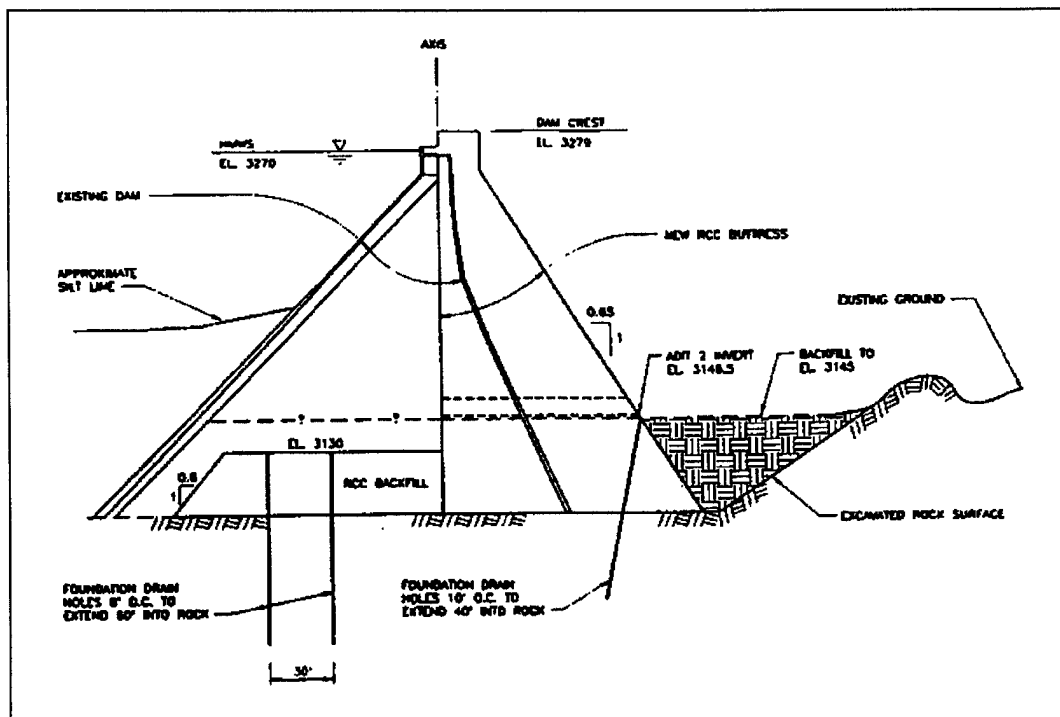
Figure 8-70. Littlerock Dam modification (Bischoff and Obermeyer 1993)
